# Reclamation of Mined Lands in Kantishna, Denali National Park and Preserve

By Guy Adema, Tim Brabets, Josh Brekken, Ken Karle, and Bob Ourso

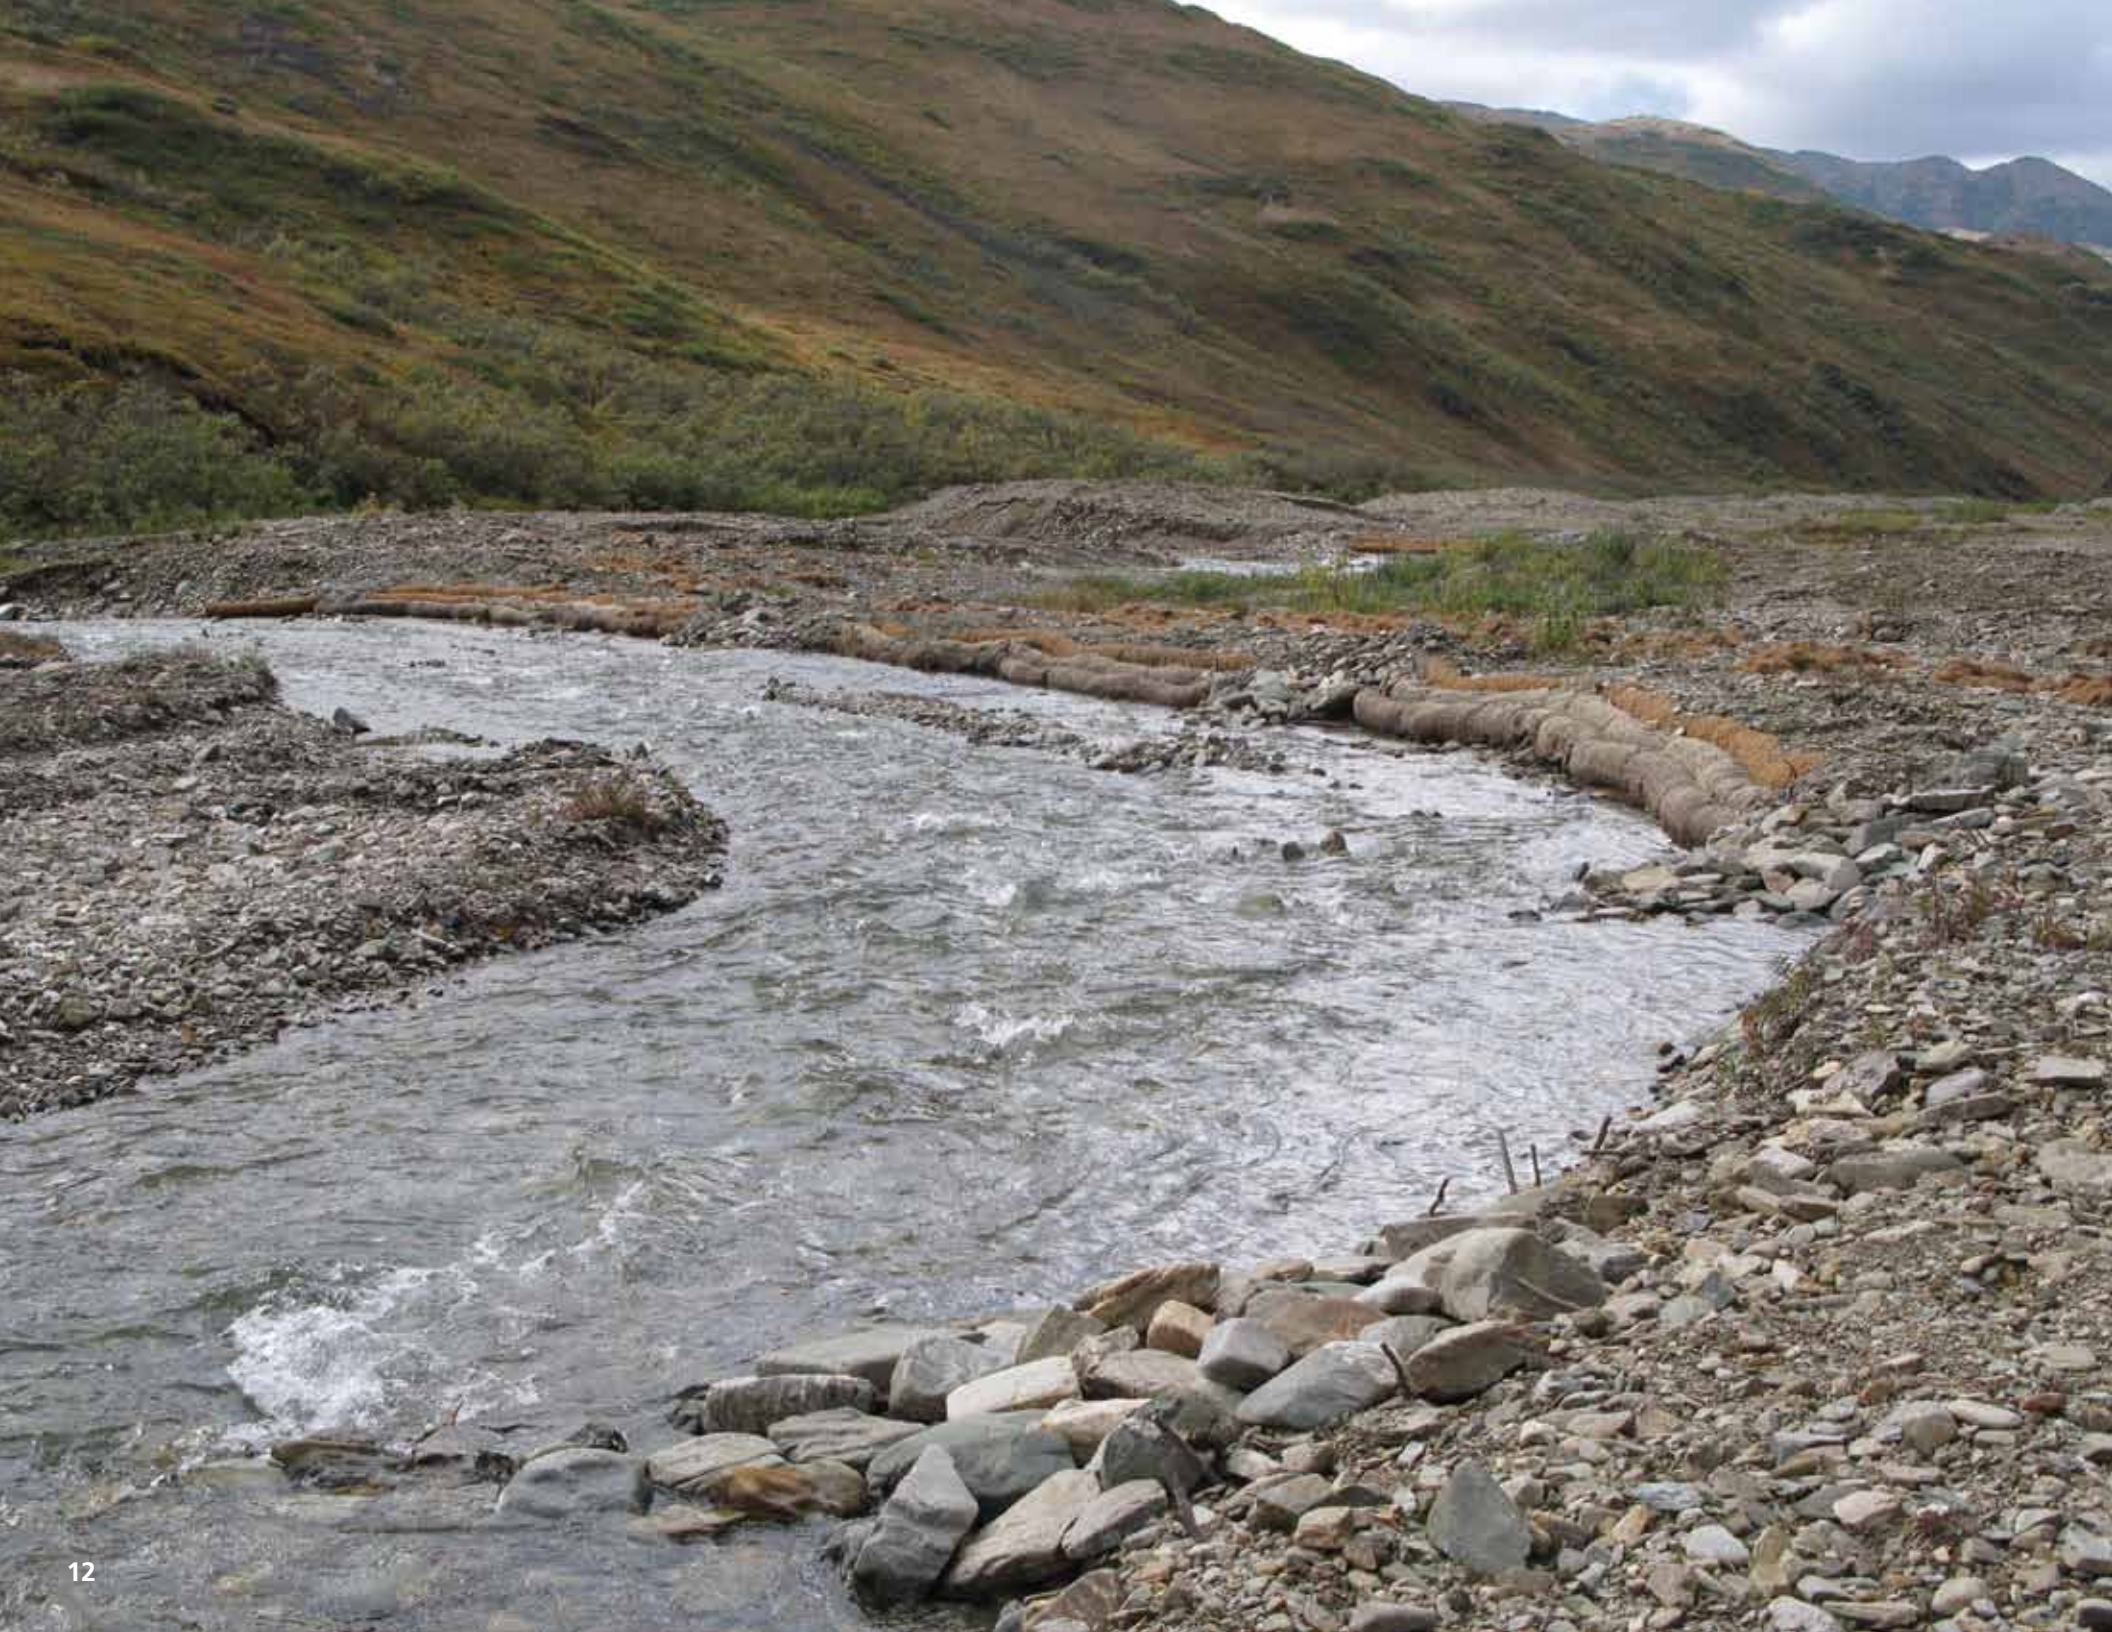
**Figure 1. Rock weirs, coir logs, and a constructed functional floodplain have helped improve water quality on Caribou Creek.**

Coconut fiber coir bio-logs and rock weirs were the primary constructed streambank stabilization

on Caribou Creek. Bio-logs were installed in four sections and were a mix of new logs and re-use of logs on site from previous reclamation efforts in 2002. Rock weirs were constructed to direct flows away from unvegetated banks during high flows.

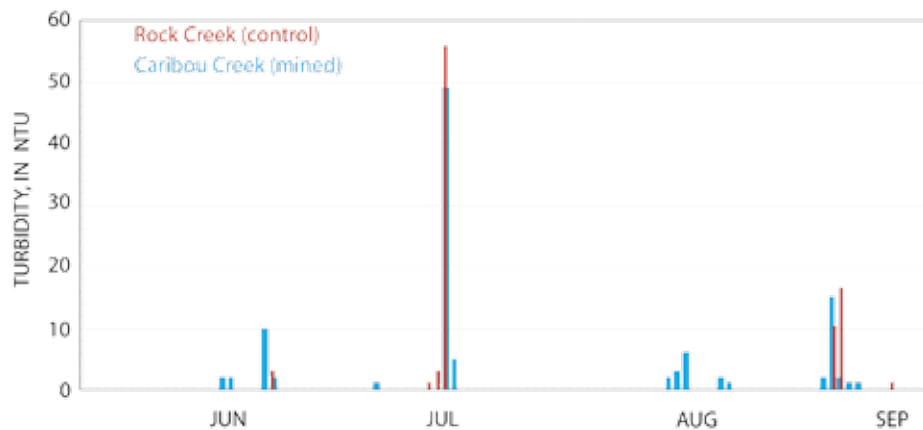
Figure 2. Comparison of average daily turbidity from Rock Creek (reference sites) and Caribou Creek (mined sites).

Water samples were collected during average flow conditions. Concentrations of suspended sediment and turbidity at all sites were low, generally less than 5 mg/L and 5 NTUs respectively. Data from previous studies in the 1980s indicated high concentrations of suspended sediment and turbidity during mining activities. The low concentrations of these constituents today indicate that the water quality has improved. Turbidity was continuously monitored during the summer at six sites; results from Rock and Caribou Creeks, representing reference and mined sites, show nearly identical patterns (Figure 2). Periods of turbidity were due to rainfall resulting in increased streamflow. The similarity in turbidity patterns between these two sites suggests that much of the mined lands in the Caribou Creek watershed have been re-vegetated, reducing the amount of sediment entering the stream.

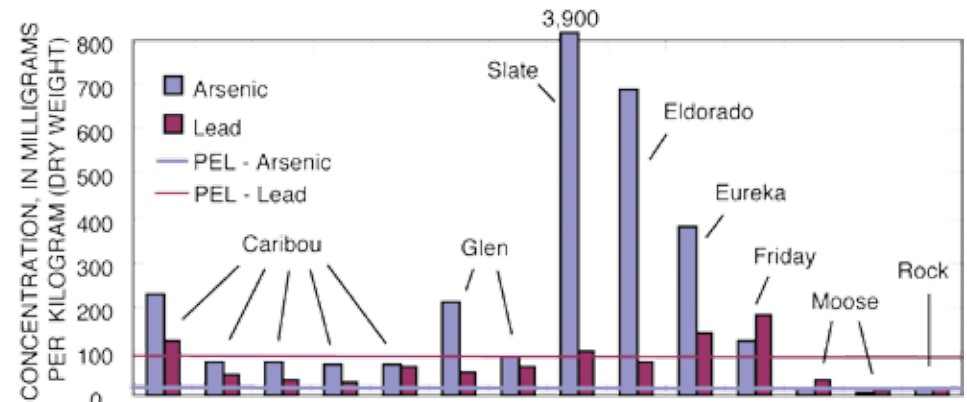
Figure 3. Concentrations of arsenic and lead measured in streambed sediments at 14 sites in the Kantishna Hills.

Streambed sediments were sampled for 34 trace elements at 14 of the sites in 2008. Metals such as arsenic and lead in streambed sediments can be harmful to aquatic life. A guideline known as the probable effect level (PEL) (MacDonald *et al.* 2000) above which adverse effects are expected to occur is used here for comparative purposes. The PELs for arsenic and lead are 17.0 and 91.3 milligrams per kilogram dry weight, respectively. Arsenic concentration for Slate Creek was 3,900 mg per kilogram and all sites with mining exceeded the PEL limit for arsenic (Figure 3). The Moose Creek and Rock Creek sites were slightly over the PEL limit. Some of the mined sites also exceeded the PEL for lead.

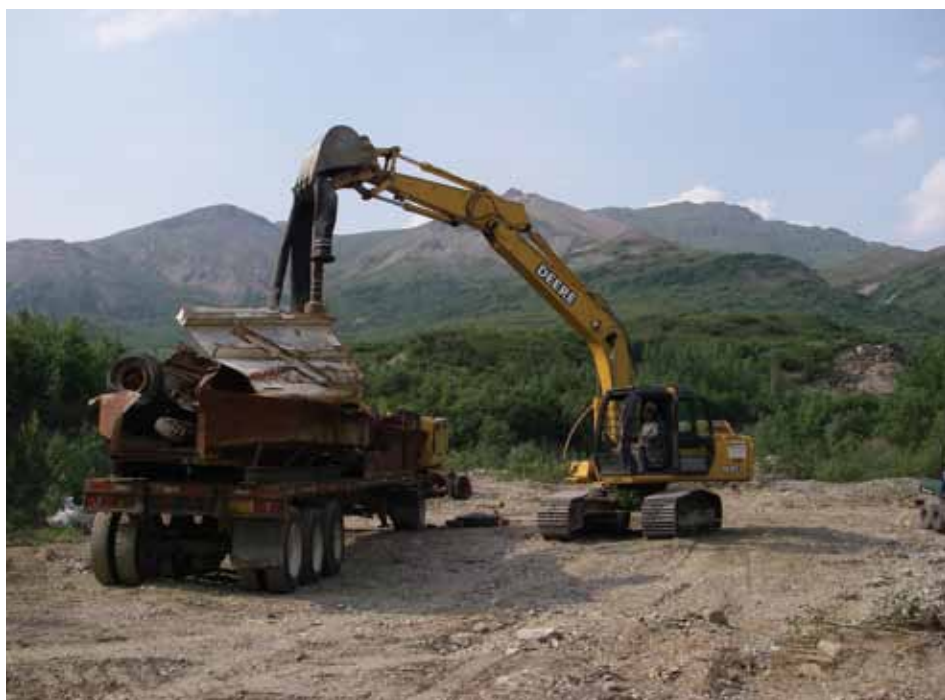
Figure 4. Removing debris from Glen Creek

Abandoned equipment and mining debris, which ranged from screening plants to school buses, was removed from all sites. The range and volume of debris removed required substantial planning and time, with 100-tons being removed from one site alone (Moose Creek). Items were transferred to Kantishna property owners for reuse (e.g. reusable buildings), recycled (e.g. scrap metal), staged for burning (e.g. wood debris) or landfilled.

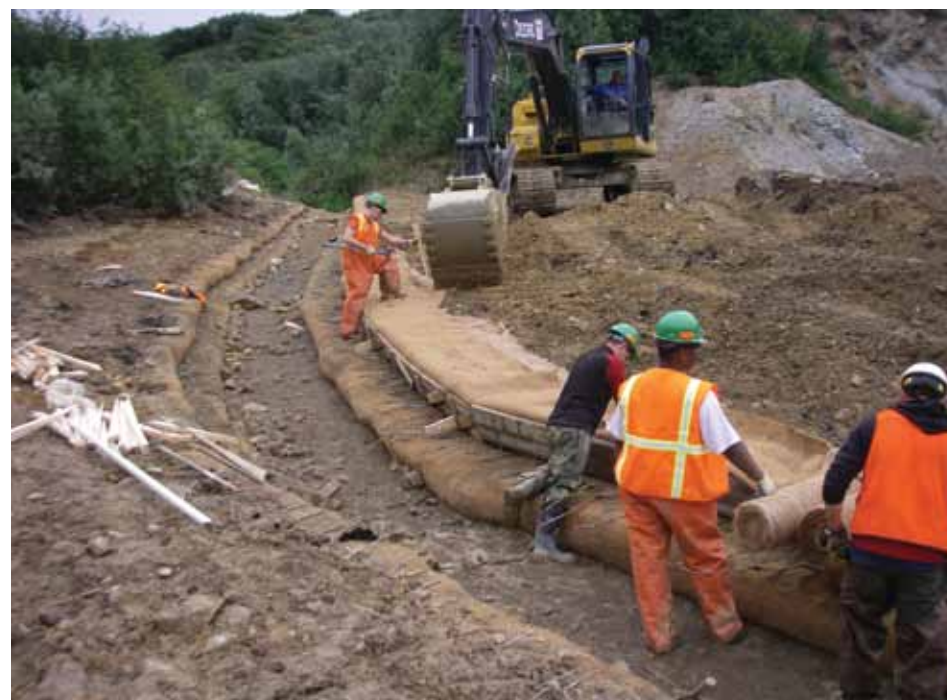
Figure 5. Construction of FES stream banks at Slate Creek.

At Slate Creek, a new 400-foot channel was construct-

ed to redirect streamflows around the main pit area of the former mine. Fabric-encapsulated soil lifts (FESLs) were used to construct the new stream banks. Additionally, willow cuttings were planted into the lifts for revegetation and long-term stability. Rock was placed in the channel to provide roughness to the steep channel (7-10% slope).

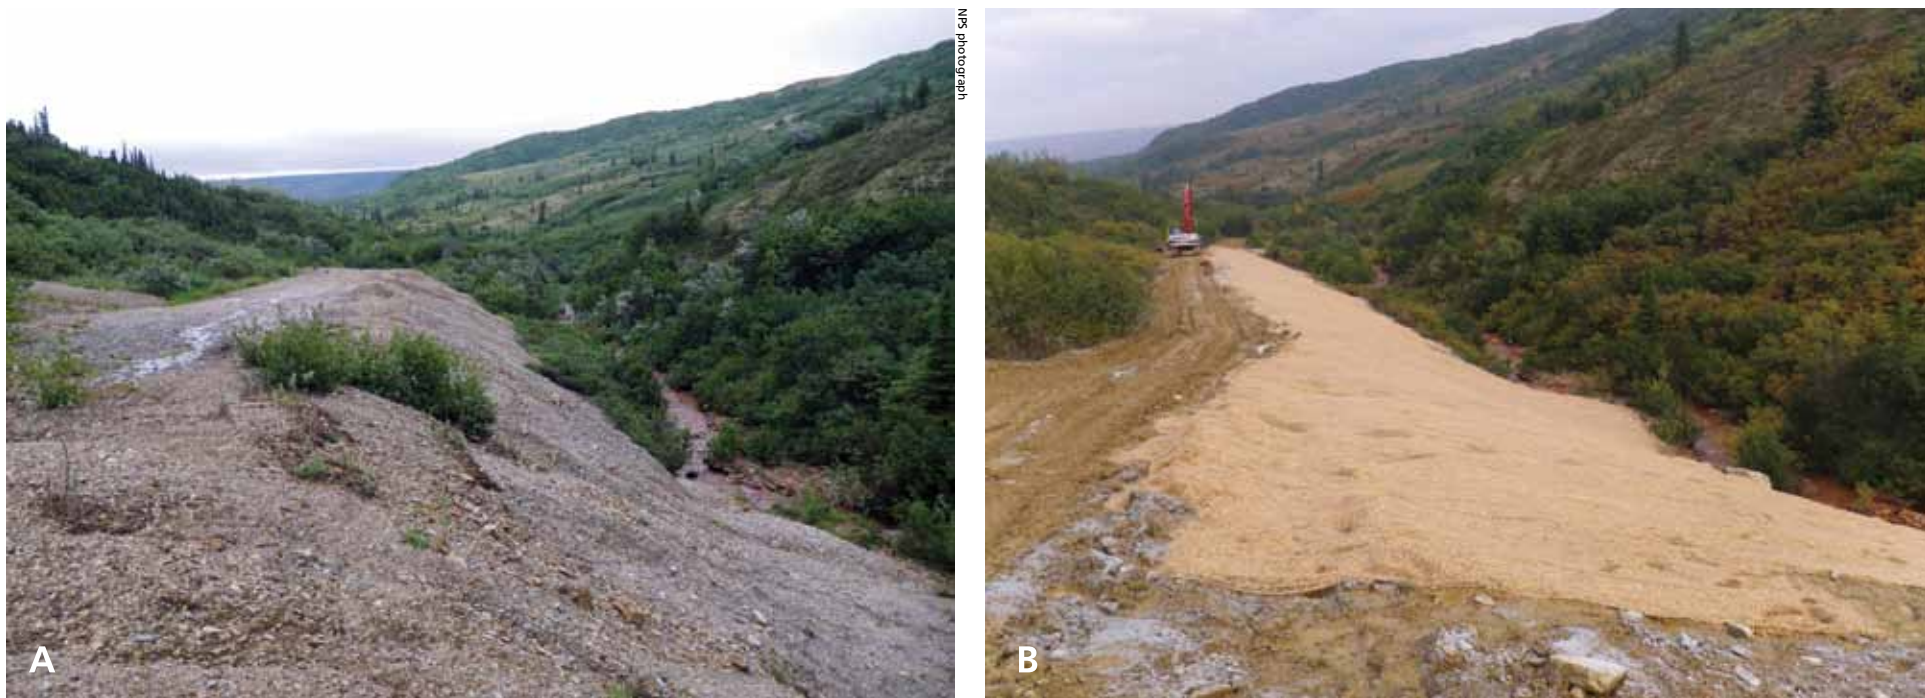
Excavation of an extended tailings pile at Slate Creek

was one of the significant challenges. The tailings were comprised of fine silt, clay, and gravels and were saturated from hillside seeps and precipitation. Excavation of the fine material, in a saturated condition, resulted in liquefying of the tailing pile at times. Excavating this extended tailings pile removed a substantial volume of loose and unstable substrate from the floodplain that was contributing to accelerated erosion, sedimentation, water turbidity, and water quality degradation to Slate, Eldorado, and to some extent, Moose Creek. The new slope, where excavated material was removed, was constructed to match the existing, natural valley side slopes and was treated with biodegradable erosion blankets.

Figure 6a, 6b. View of extended tailings pile showing pre-construction conditions (left) and post-construction slope treatment and erosion blanket installation.

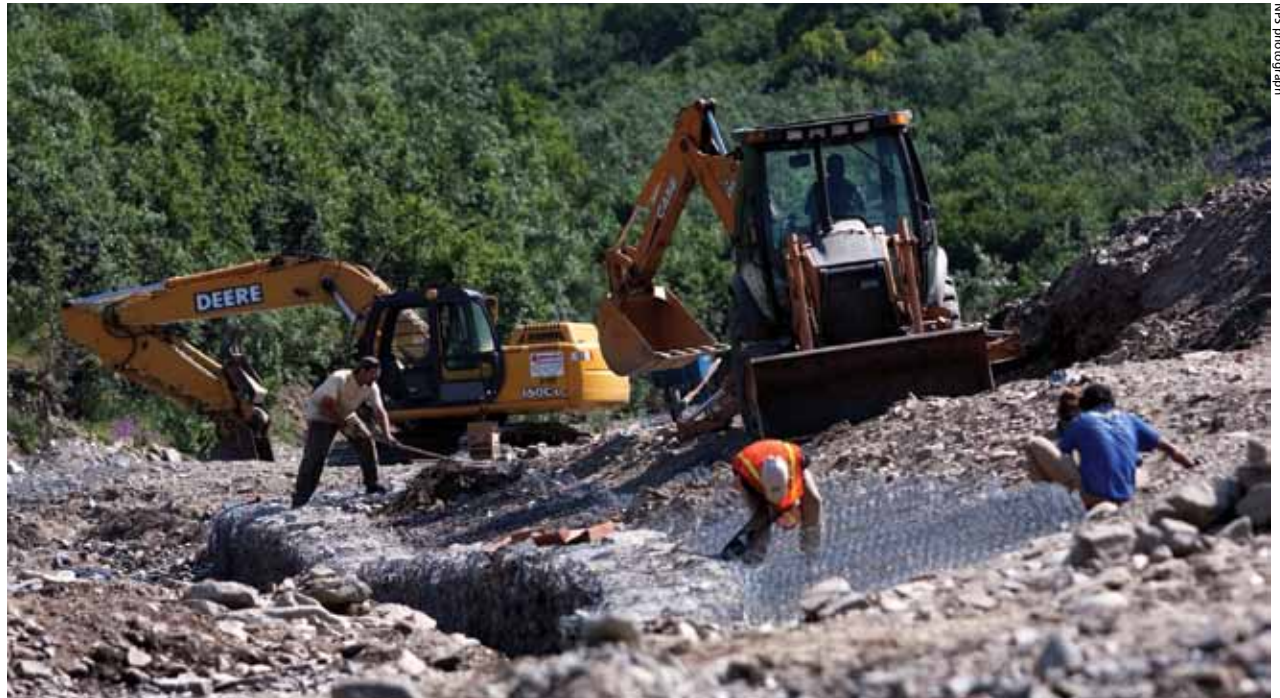
Figure 7. Field crews assemble bank stabilization structures.
